Case Study

Repair service reconditions subsea drilling equipment and saves significant scrappage costs for major oil and gas equipment manufacturer

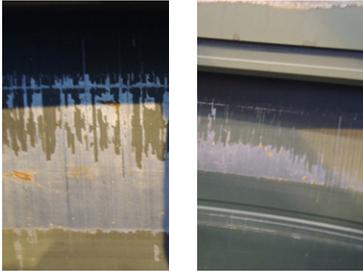
Before

A critical part of the drilling system; an outer connector sleeve, had a severely damaged sealing bore which had been scored during the manufacturing process.

Firstly the part was machined to remove surface defects. This involved approximately 508 microns being removed from the sealing diameter.
